ENGINEERING PROCESS FAILURE—HYATT WALKWAY COLLAPSE

By Piotr D. Moncarz,¹ P.E., Fellow, ASCE, and Robert K. Taylor,² P.E.

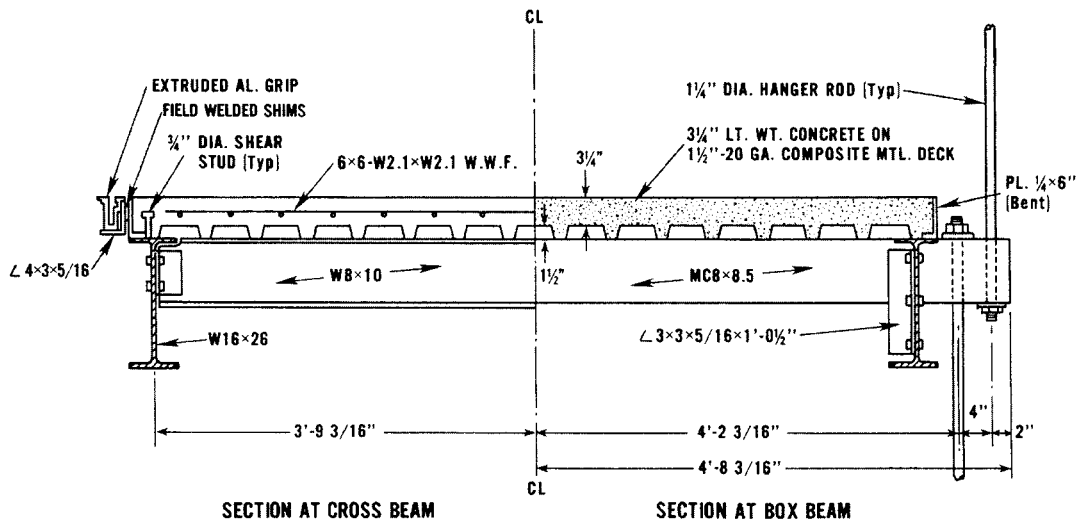
Fig. 3 provides a typical transverse section of the walkway deck. The deck was formed of lightweight concrete placed over a corrugated metal deck and was supported by two longitudinal I-beam stringers, W16 × 26, which in turn transferred the weight of the bridge and the superimposed live load to three transverse box beams per bridge. The transverse box beams were assembled of two welded flange-to-flange channel sections, MC8 × 8.5. The 32 mm (1 1/4 in.) diameter hangers passed through a hole in the channel flanges and carried the weight transferred by them through a nut and washer installed on the threaded hanger underneath the girder. For the bridges positioned in the same vertical plane (Fig. 1), the lower and upper bridges were suspended by the hanger attachment to the roof truss. Thus, the upper hanger carried the loads of both bridges, whereas the lower hanger carried only the load of the lower bridge. The contact area between the hanger rod washer and weld at the toe of the channels (Fig. 3) was ground down for flatness, thus further reducing the connection between the channel flanges.

FIG. 3. Typical Transverse Section of Walkway

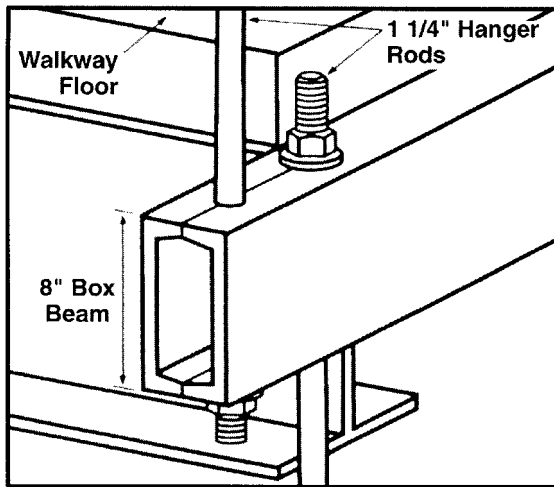
FIG. 4. As-Built Connection

nut through two stories seemed to be highly impractical. Thus, the contractor suggested a change to the drawing whereby each single hanger rod would be replaced by two rods: one going from the lower to the upper bridge, the second going from the upper bridge to the roof truss (Fig. 4). The dramatic impact of this change is shown in Fig. 5. The loads transferred through the contact between the upper bridge box beam and the nut and washer assembly had approximately doubled in the new arrangement. Instead of the force being equal to the tributary load of the upper bridge only, it became the sum of the tributary portion of both the upper and lower bridges.

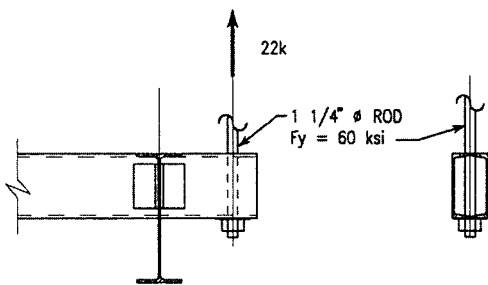
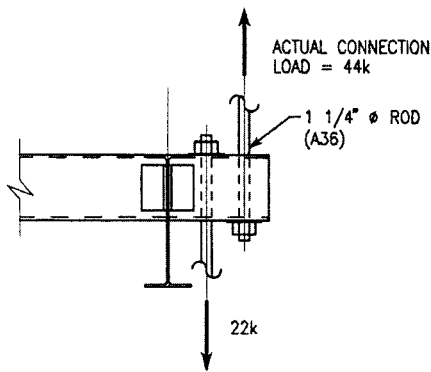
FIG. 5. Fatal Connection Evolution

While the key contributor to the failure—the change of the end connection detail as depicted in Fig. 5—was quickly identified, significant effort was expended to quantify the effect of other existing or potential contribution causes. Initial discussions speculated as to the impact of vibrations caused by the onlookers standing on the bridges and rhythmically moving to the tune of the music. Questions were raised as to the importance of additional concrete used in leveling the floor of the walkway, the size and quality of the box beam flange weld connection, and even the strength of the washers under the nuts.

- The Hyatt walkway collapse was a direct result of doubling the load on the suspension hanger rod-to-box beam connections through a change in the construction detail.

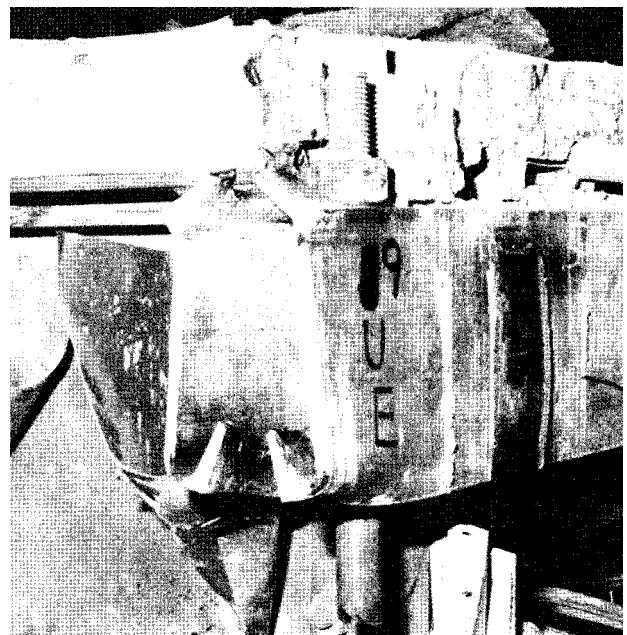
The failure of the connection between the hanger rod and the box girder is well documented through the physical evidence. The deformed end-connections of the upper bridge box beams clearly indicate hanger pullout. The east side rods (in the foreground of Fig. 1) suspended from the ceiling of the atrium were straight and vertical after the failure, while the west side rods had an inclination. This suggested hanger pullout initiation on the east side of the upper bridge. The central of the three east side connections showed the most symmet-

FIG. 6. Box-Beam Connection after Pull-Out of Top Suspension Rod

rical deformations, suggesting the initiation of the collapse at the central, east connection of the upper bridge.

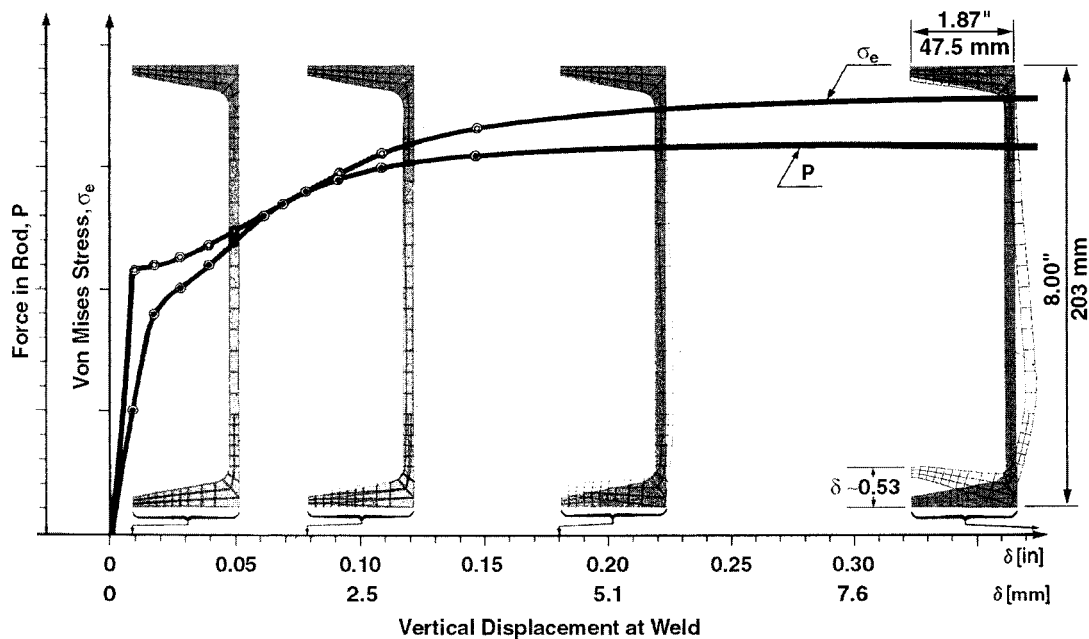
FIG. 7. Summary of FEA of Box Beam Showing Small Displacement at Large Plastic Deformations

parent from the summary of the finite-element study by the writers of this paper presented in Fig. 7. At the dead load level the plastic deformation of the channel flanges of 3–6 mm (0.10–0.15 in.) was present. This magnitude of deformation could not be observed without disassembling the connection and measuring the deformation against a straight edge. Observation was impractical, since the steel construction was covered by finish and fireproofing.

Both the experimental and analytical studies showed minimal impact on the ultimate capacity of the connection by the weld size in the as-configured construction detail. The finite-element analysis showed the importance of the channel flange stiffness to the stresses that led to the failure. The obvious indication is that the addition of a plate between the flanges of the channels and the washer could have successfully addressed this problem by stiffening the channel bottom.
